**WETLAND DELINEATION AND IMPACT ASSESSMENT REPORT: FOR THE  
PROPOSED MINING RIGHT APPLICATION FOR THE PROPOSED  
MINING OF COAL ON THE REMAINING EXTENTS OF PORTIONS 18, 21,  
55, 64, 69, 85, 213 OF FARM TENBOSCH 162 JU, PORTIONS 2, 5 AND  
6 OF FARM TURFBELT 593 JU AND FARM TECKLEBURG 548 JU  
BARBERTON MANAGERIAL DISTRICT OF THE MPUMALANGA  
PROVINCE.**

**TENBOSCH MINING (PTY)  
LTD**

**April 2023**

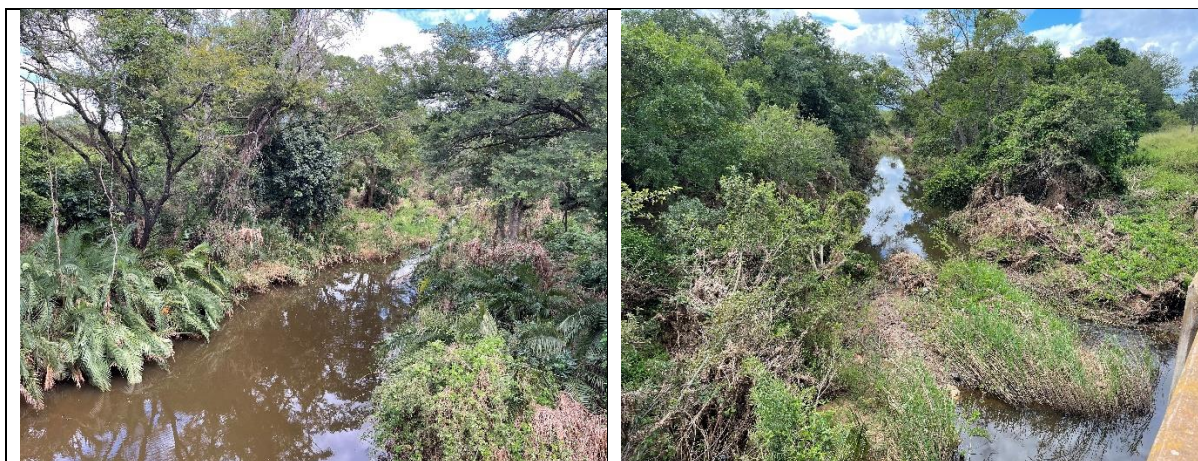
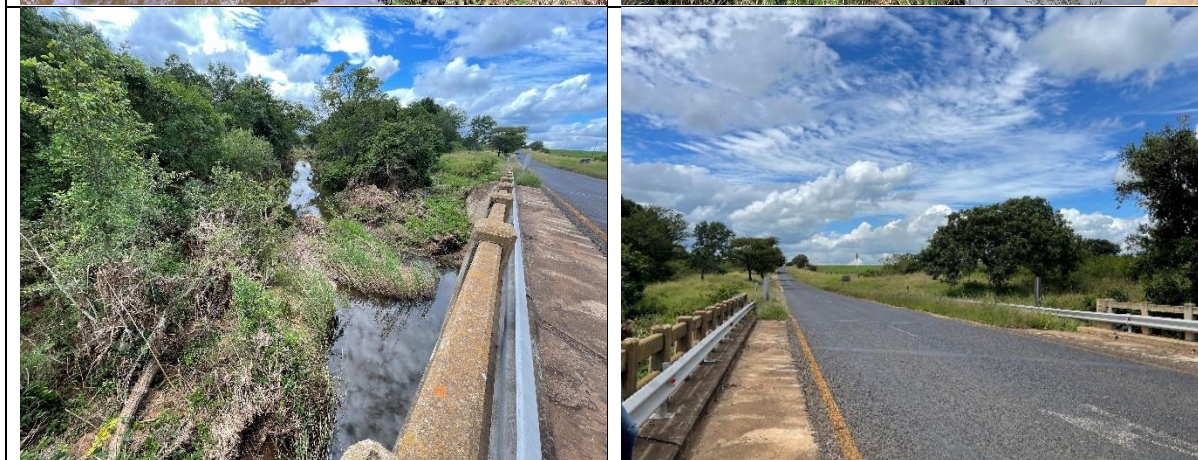
**COMMENT 1: NGWETI RIVER AND ASSOCIATED BRIDGE**

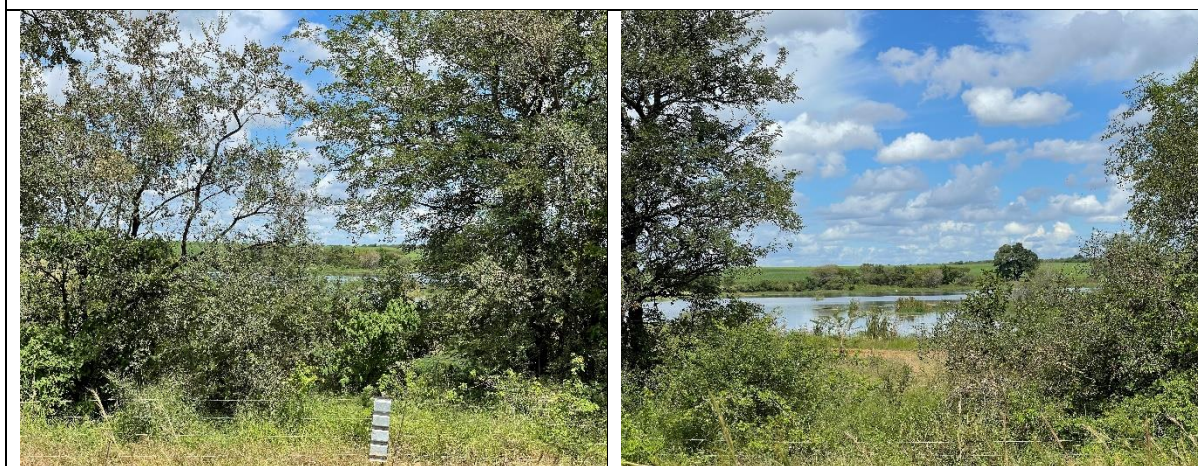
**COMMENTS 2: WETLAND/DAM OBSERVED ONSITE**

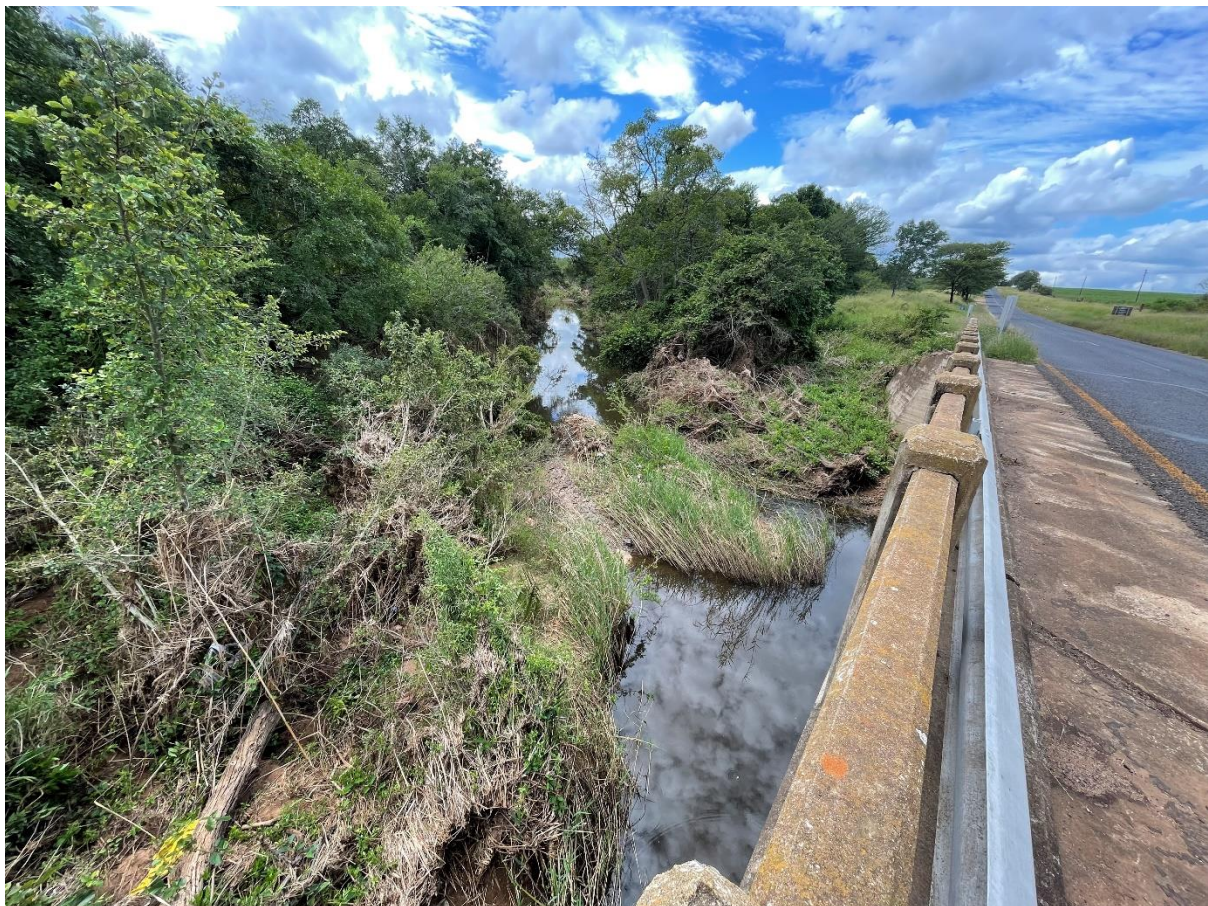
Figure 9: Slope of the study site

The study site can be characterized as Gently to moderately sloping upper pediment slopes (**Figure 9**).

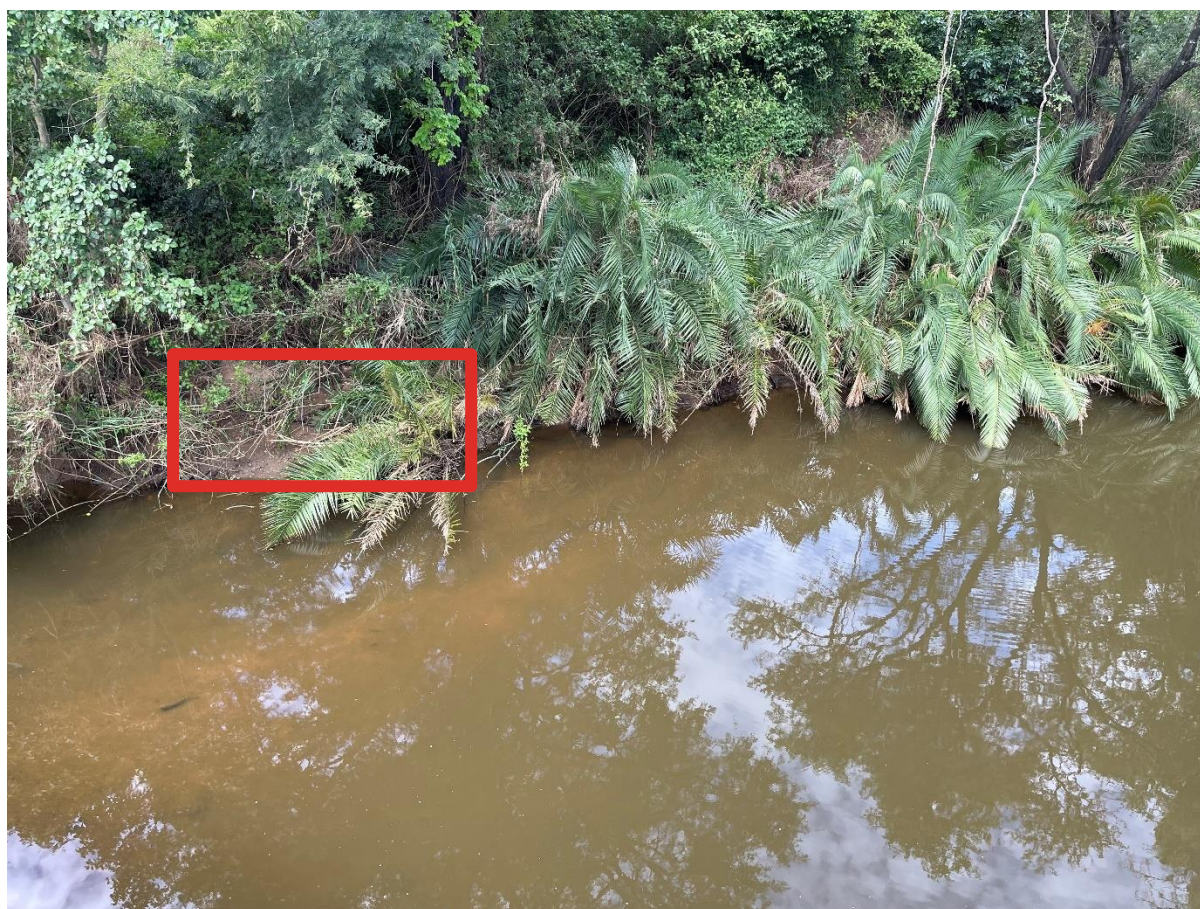
**Figure 10:** Soil Observed within one of the.

The watercourses onsite have water and support a host of hydrophytes and alien invasive plant species. Wetland areas were identified and mainly delineated according to the presence of hydric (wetland) soil types. Hydric soils are defined as those which show characteristics (redoximorphic features) resulting from prolonged and repeated saturation. Characteristics include the presence of mottling (i.e., bright insoluble manganese and iron compounds) a gleyed matrix and/or Mn/Fe concretions. The watercourses consist mainly of sand (**Figure 10**).

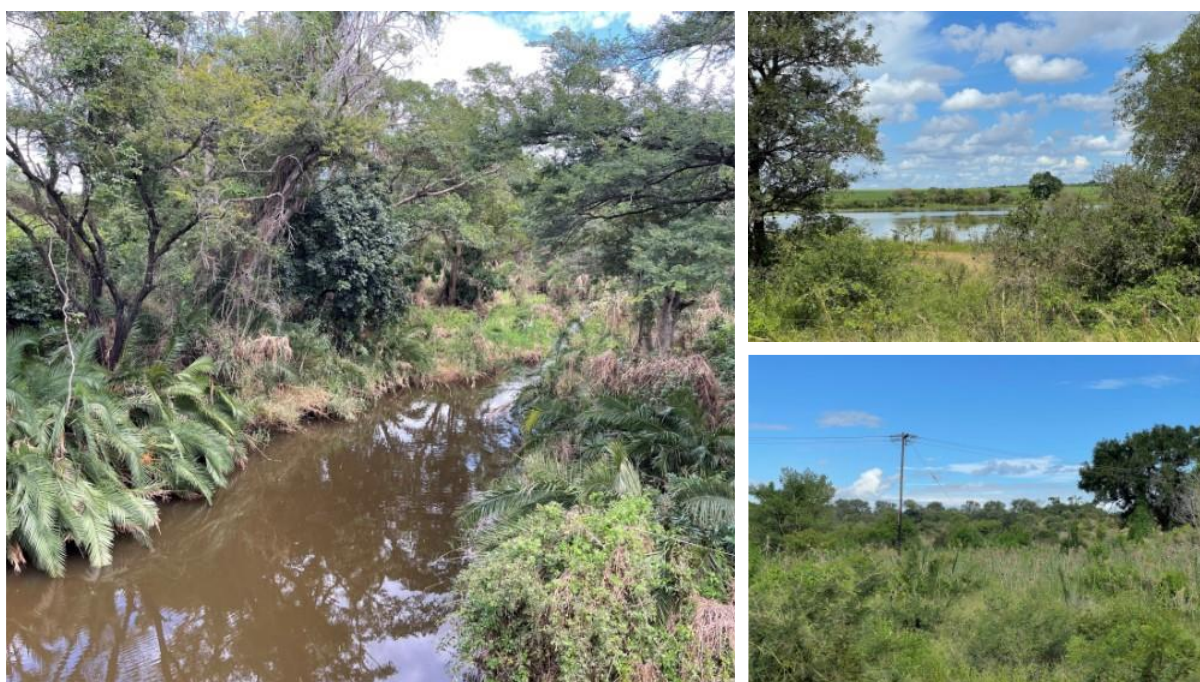
**Figure 18: Typical Freshwater Habitat onsite.**

The freshwater habitats (watercourses) onsite consist mainly of terrestrial plant species (Figure 16). It is important to note that plants such as algae, water lilies, and willow trees help keep the water clean by using their root systems to filter pollution and excess nutrients from the water. The watercourses have hydrophytes such as *Typha capensis*. During the site inspection there was evidence of avifaunal species within the watercourses (Figure 17).
